## **Building Analysis Report**

## **SAMPLE REPORT**

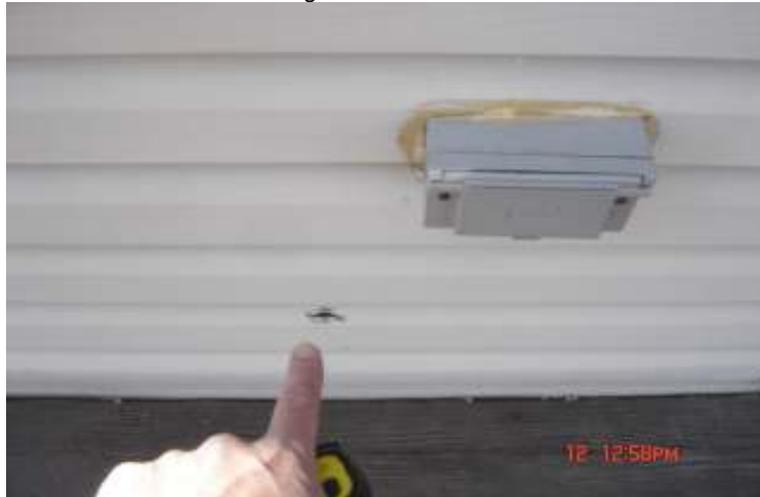
**Siding:** Vinyl, Brick  
**Conditions:** **Physical damage** --- Physical damage was noted and should be repaired.  
Location: Minor hole to siding at deck

**Rating:** Marginal

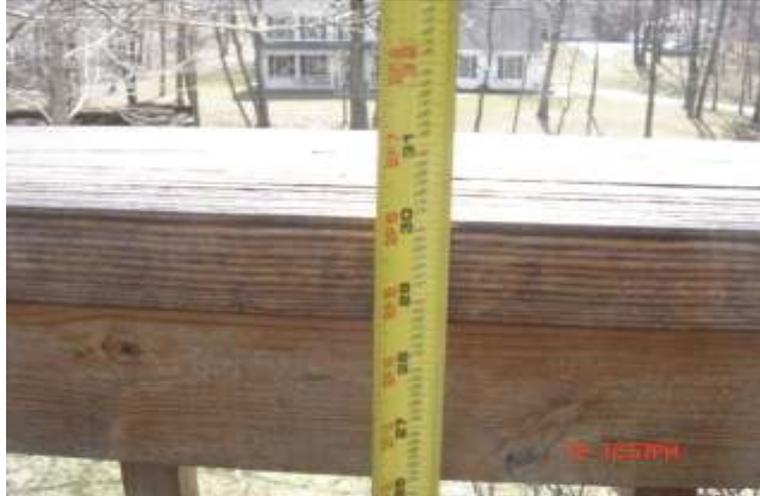
Location: Deck

Conditions: **Railing too low** --- Safety railing is too low. Have railing raised to a minimum of 36 inches.

Rating: **Safety Concern**

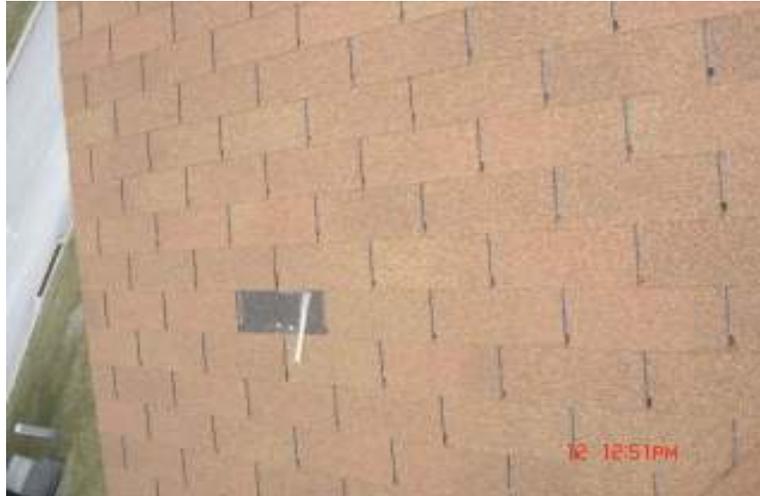
Location: one missing tab on front right near chimney

Asphalt Shingle  
**Missing/cracked shingle** --- Roof has missing or cracked shingles that should be replaced. Water penetration could occur.

Rating: **Marginal**

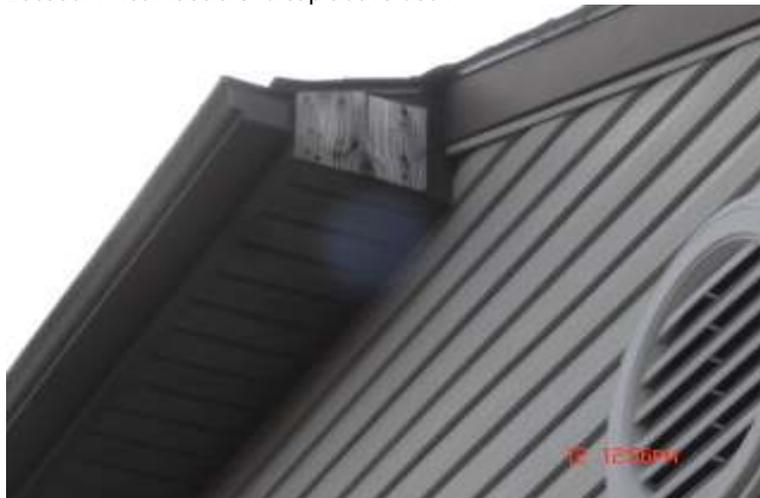
Location: Rear fascia end cap above deck

Metal  
**Missing sections** --- Sections are missing and should be repaired to help prevent water penetration.

Rating: **Marginal**

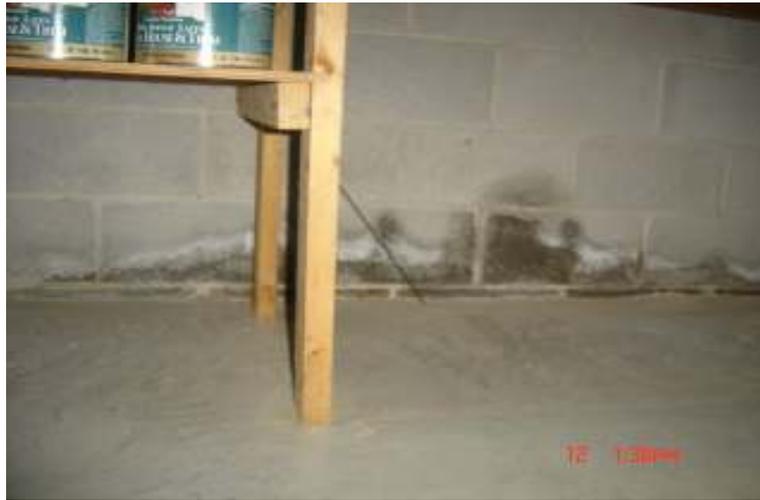
**Type:** Basement, Crawl Space  
**Conditions:** **Minimal ventilation** --- Ventilation appears to be minimal. Additional ventilation may be needed to be installed to help prevent moisture and condensation problems. Correct as needed.  
Location: crawl space  
**Rating:** *Marginal*  
**Materials:** Block  
**Conditions:** **Water stains** --- Water stains were noted. Stains are evidence of prior water penetrations.

Rating: Monitor

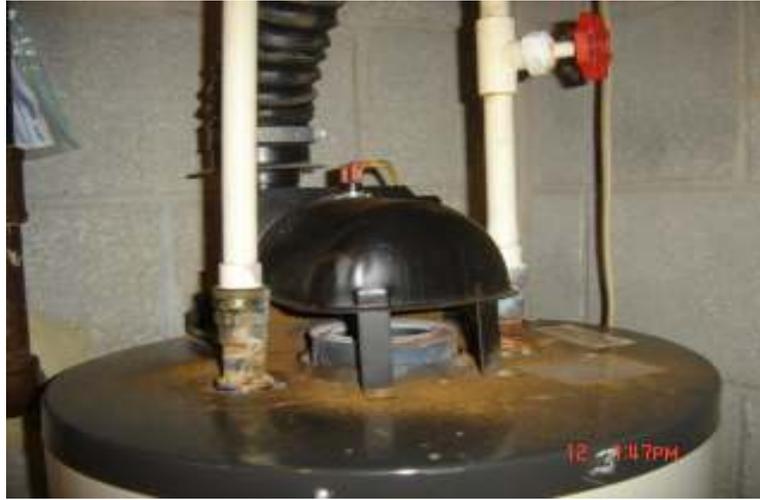
**Type:** Natural Gas  
Conditions: **No copper stems** --- Copper stems copper pipes that are approx. 18" long connecting directly into the water heater. Copper stems are preferred since they are less susceptible to heat damage from the fueled water heaters and flues. Copper stems should be installed to prevent undesirable results.

**Older Unit** --- The item or system is what is considered to be "older", this simply means that is nearing its' maturity and may require replacement in the near future. You may want to monitor the system or appliance and budget for a future replacement.

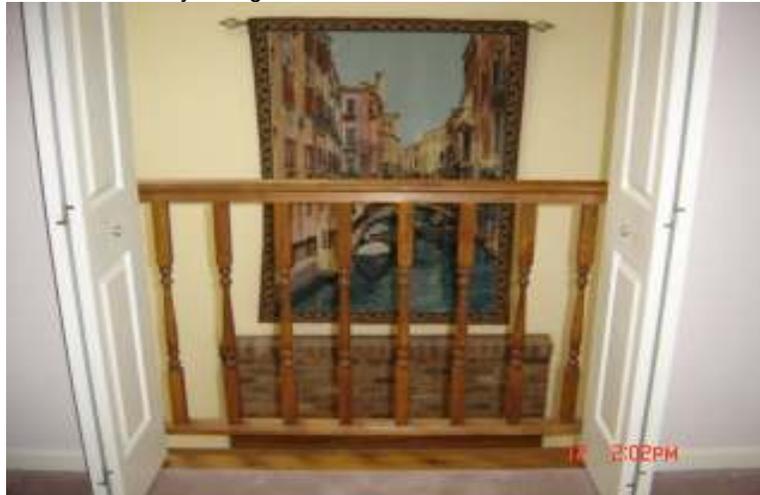
**Balconies:** Wood  
**Conditions:** **Spindles too wide ---** Spindles are too far apart. Additional spindles should be added to rails to lessen the spaces between them. This can be hazardous to small children. Recommended to be no more than 4" apart.  
Location: balcony railing

**Rating:** **Safety Concern**
